# **SITE VISIT REPORT ON APNRT ICON TOWER PROJECT, AMARAVATHI**

**Submitted as a part of Internship Training**

**Submitted by --** M. TARUN KUMAR – 22B91A0189,  
B. Tech -- Civil Engineering,  
SRKR Engineering College, Bhimavaram.

**Internship Organization –** VSR CONSULTANTS, Hyderabad.

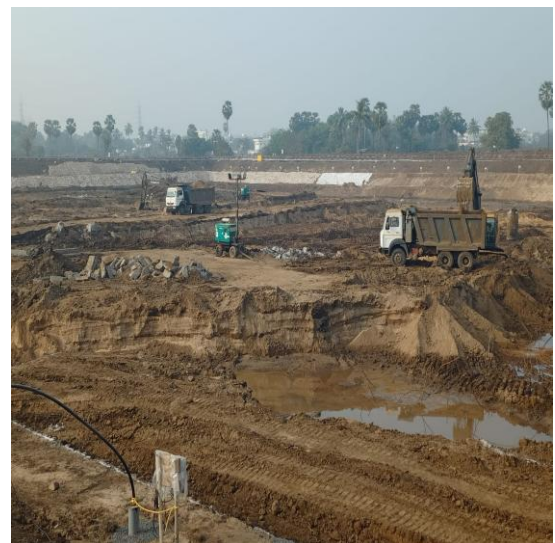
Excavation at the APNRT Icon Tower Project is carried out mainly for basement construction and foundation works. Since the project involves multiple basement levels, excavation plays a critical role in the overall construction process. The total excavation depth required is approximately **10.925 meters**, and the activity demands careful planning due to weak soil conditions and high groundwater levels at the site.

To maintain stability and ensure safety, excavation is executed in a **stage-wise manner**. The process is divided into **four stages** based on depth and soil behaviour. During **Stage 1 and Stage 2**, excavation is carried out with a **slope ratio of 1:1.5**, which helps in preventing soil collapse during shallow excavation. As excavation progresses to greater depths, **Stage 3 and Stage 4** are executed with a flatter **slope ratio of 1:2** to handle increased earth pressure and groundwater influence.

**Berms are provided at each excavation stage** to improve slope stability and ensure safe working conditions. A berm width of **2.5 meters** is maintained at the first stage, while a width of **1.5 meters** is provided for the remaining stages. These berms reduce the effective slope height and act as safety platforms during excavation. Excavation is carried out carefully around already completed pile foundations to avoid any damage to the piles.

Due to the presence of groundwater, excavation works are closely coordinated with the **dewatering system**. Continuous pumping is required to keep the excavation dry and prevent softening of the soil at the base. Regular monitoring of slopes, berms, and excavation faces is carried out by site engineers to identify any signs of instability. Proper supervision and controlled excavation ensure safe and efficient progress of basement construction.

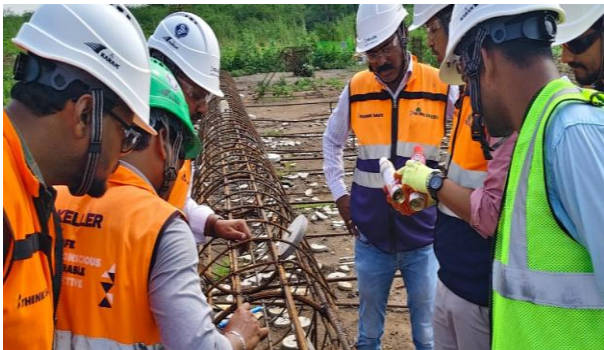
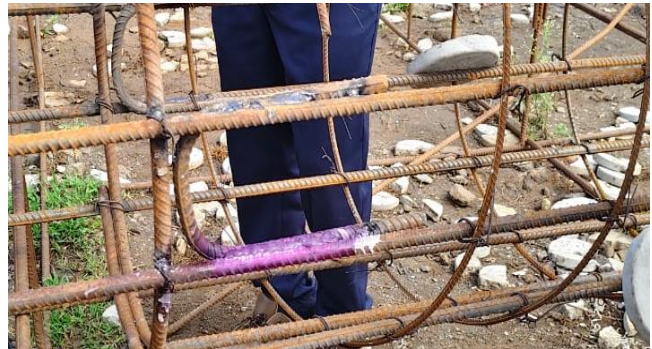
Due to high groundwater levels, dewatering is a critical activity. 88 bore wells of 20 m depth are provided with dewatering pumps. Continuous pumping helps keep the excavation area dry and stable. All 88 pumps together discharge about 5,06,880 Liters per hour.

Quality control measures include slump tests (150–180 mm), concrete cube casting and testing, reinforcement cage inspection, and Dye Penetrant tests on welded joints. Cover blocks are checked to ensure proper concrete cover. All tests are conducted under engineer supervision.

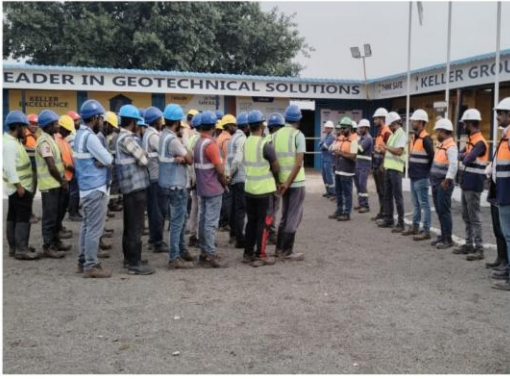
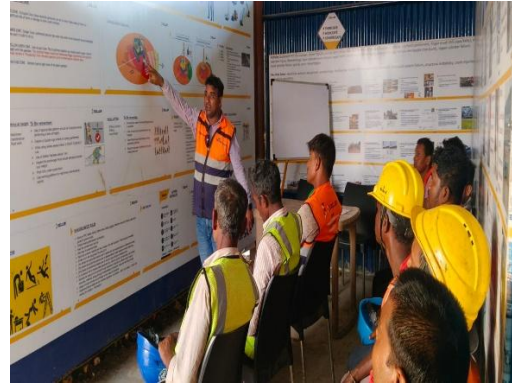
Strict safety rules are followed at the APNRT Icon Tower Project to ensure a safe working environment for all site personnel. The use of **Personal Protective Equipment (PPE)** such as helmets, safety shoes, and reflective jackets is **mandatory** for everyone entering the site. Workers are allowed to perform tasks only after proper safety briefing, and unsafe practices are immediately stopped by the safety team.

A **permit-to-work system** is strictly implemented for high-risk activities such as lifting operations and hot work. All lifting activities are carried out using certified equipment and proper signalling methods. Before allowing the movement of heavy machinery, **working platforms are thoroughly inspected and strengthened** to prevent accidents. Regular safety inspections and supervision help in minimizing risks and maintaining a disciplined safety culture at the site.
